**Wallowa-Whitman National Forest  
Fisheries Habitat Improvement  
FY 1991 Annual Report**

**Bonneville Power Administration  
May, 1992**

**Project No. 84-9**

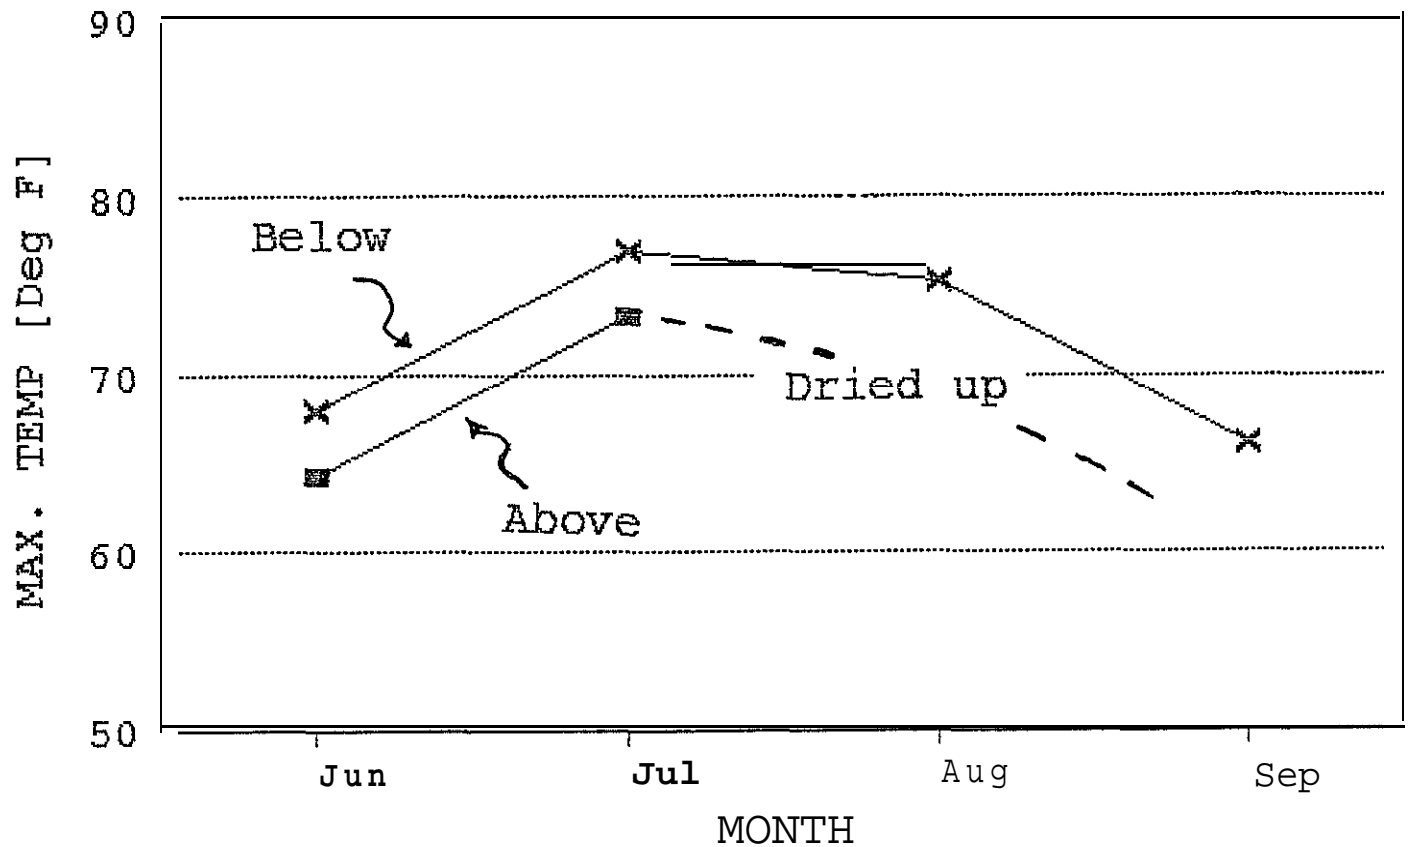
FIGURE 8. Monthly maximum summer streamwater temperatures above and below BPA project area for Chesnimnus Creek (Section G) during 1991.

Figure 8. shows the maximum streamwater temperatures for Chesnimnus Creek (Section G). This section received BPA rehabilitation work (woody debris input) during July 1991. The section is approximately 1.3 mile long. The data collected this year was to determine baseline summer streamwater temperatures. Both the above and below temperature stations recorded hot temperatures during June and July (70-77 degrees F). The below project area temperature station recorded 55 days during June thru September that maximum temperatures were 68 degrees F or greater.

Figure 8. indicates a heating trend thru this section (approximately 4 degrees F) at least for the months of June and July. This trend probably would exist for August and September (it may be a degree or two higher based on temperature measurements on other sections of Chesnimnus Creek) but could not be assessed since the station above the project area dried up in mid-July. This section of Chesnimnus Creek has poor water quality for salmonid populations.

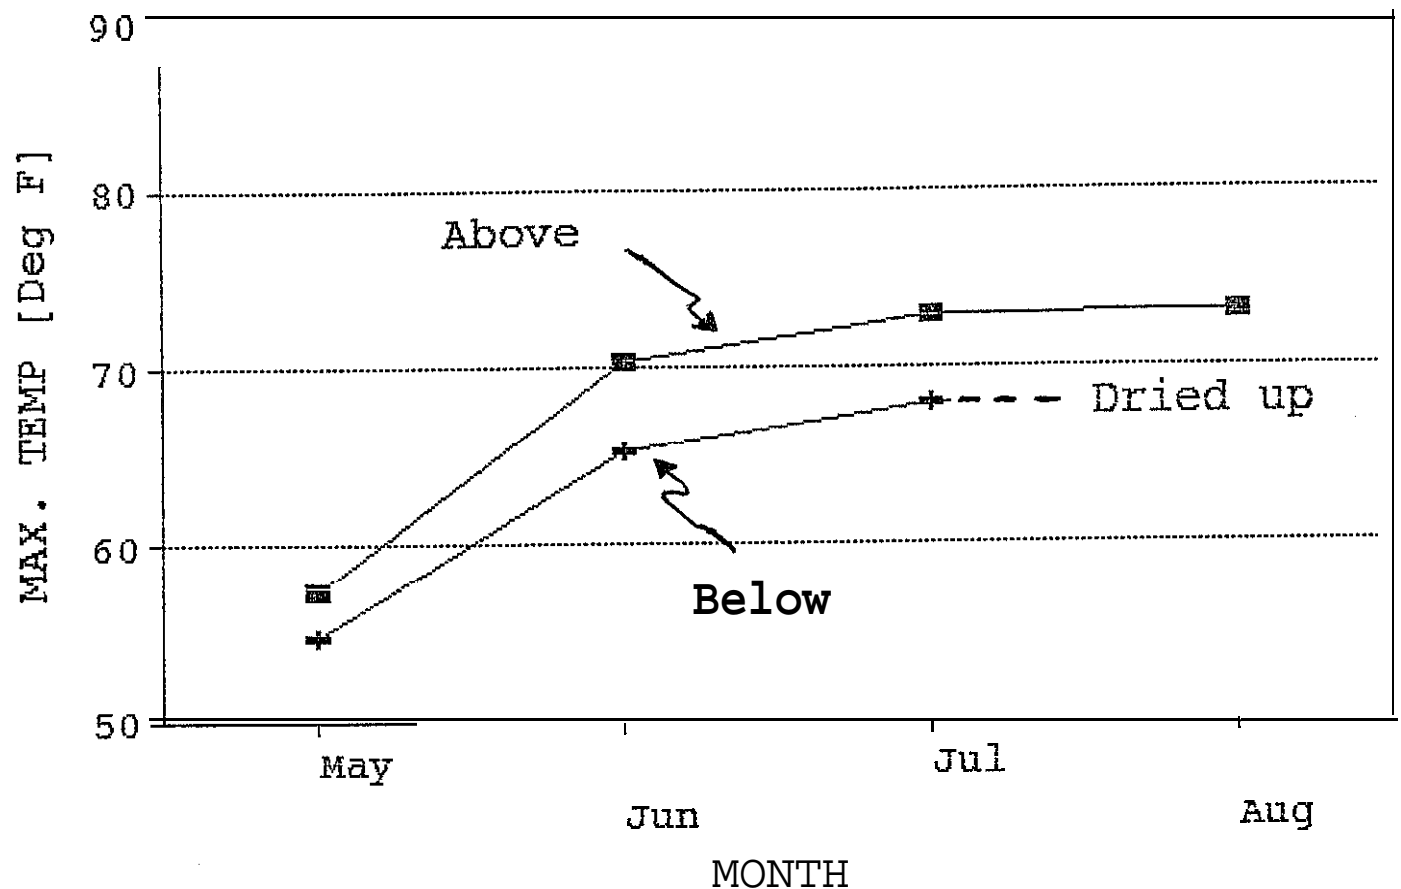
FIGURE 9. Monthly maximum summer streamwater temperatures above and below BPA project area for Davis Creek during 1991.

Figure 9. shows a cooling effect thru the BPA project area of 3-5 degrees F for May, June, and July. Maximum streamwater temperatures below the project area stayed below 68 degrees F up to July 12, 1991. After this date the stream dried up. The temperature station above the project area had maximum temperatures of 70-73 degrees F for June, July, and August. This station had 32 days where the streamwater temperatures were 68 degrees or greater. This station also dried up, but it occurred later in the season (August 13, 1991). Previous surveys conducted by Oregon Dept. of Fish and Wildlife (ODF&W, 1966) for this section of Davis Creek also indicated parts of this reach being dry in July.

Davis Creek within the BPA project area provides an important cooling reach for the Swamp Creek basin. The mouth of Swamp Creek currently has high streamwater temperatures (>68 degrees F). This section of Davis Creek, however, provides limited summer salmonid habitat due to high water temperatures and low water quantities during the summer. This section may have the potential to run water all summer long and provide dense riparian vegetation since it runs thru a low gradient meadow-like valley. The current monitoring projects will help determine if this potential can be achieved.

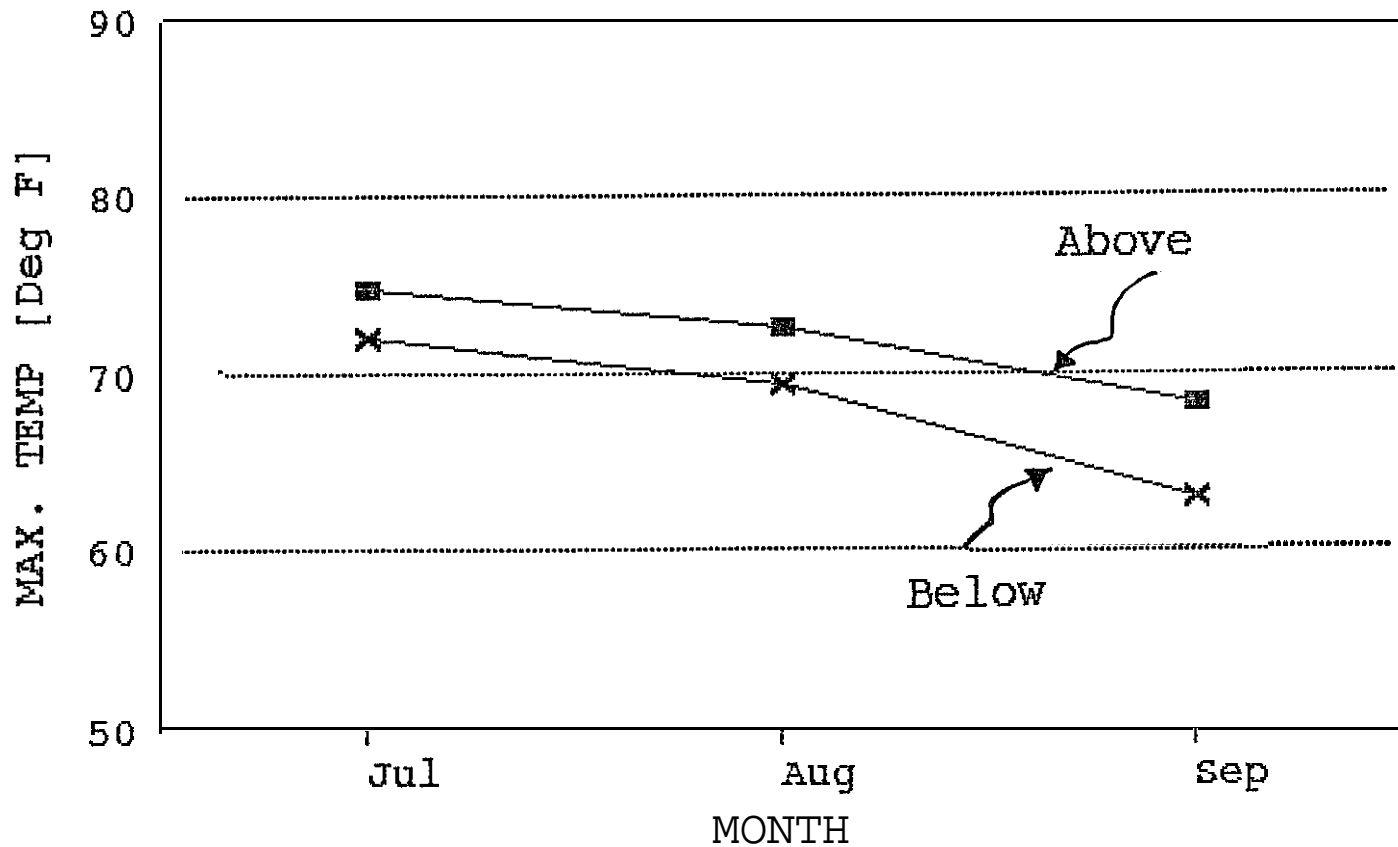
FIGURE 10. Monthly maximum summer streamwater temperatures above and below BPA project area for Elk Creek (fence exclosures 7-11) during 1991.

The fence exclosures on Elk Creek (#7-11) are approximately 7 years old. The reach of stream monitored was 1.2 miles long. Figure 10. illustrates a cooling trend from the upstream exclosure (#7) to the downstream exclosure (#11) of 3-5 degrees F. This was also documented during FY91. During 1983 streamwater temperatures stayed constant thru the reach. Water quality is improving. Reduction of water temperatures appears to be directly connected to BPA project work rather than a meteorological change (i.e., wetter conditions; more water available in watershed for cooling). Summer flows for rivers in nearby basins were lower in 1991 and 1991 than 1983 (20-40% lower depending on the month). The Elk Creek project indicates that with riparian plantings and livestock fence exclosures it takes 7-8 years before decreases in water temperature can be expected.

Streamwater temperatures, however, still remain high for Elk Creek; the temperature stations above and below this section recorded maximum temperatures between 69-75 degrees F for July and August. Additionally, the above station had 54 days of greater than 68 degrees F while the below station had 37 days. The Elk Creek project is helping reduce the already high temperatures flowing into the project area. Riparian shading has not reached its potential for Elk Creek so further reduction in stream temperature is expected in the future as the canopy grows.

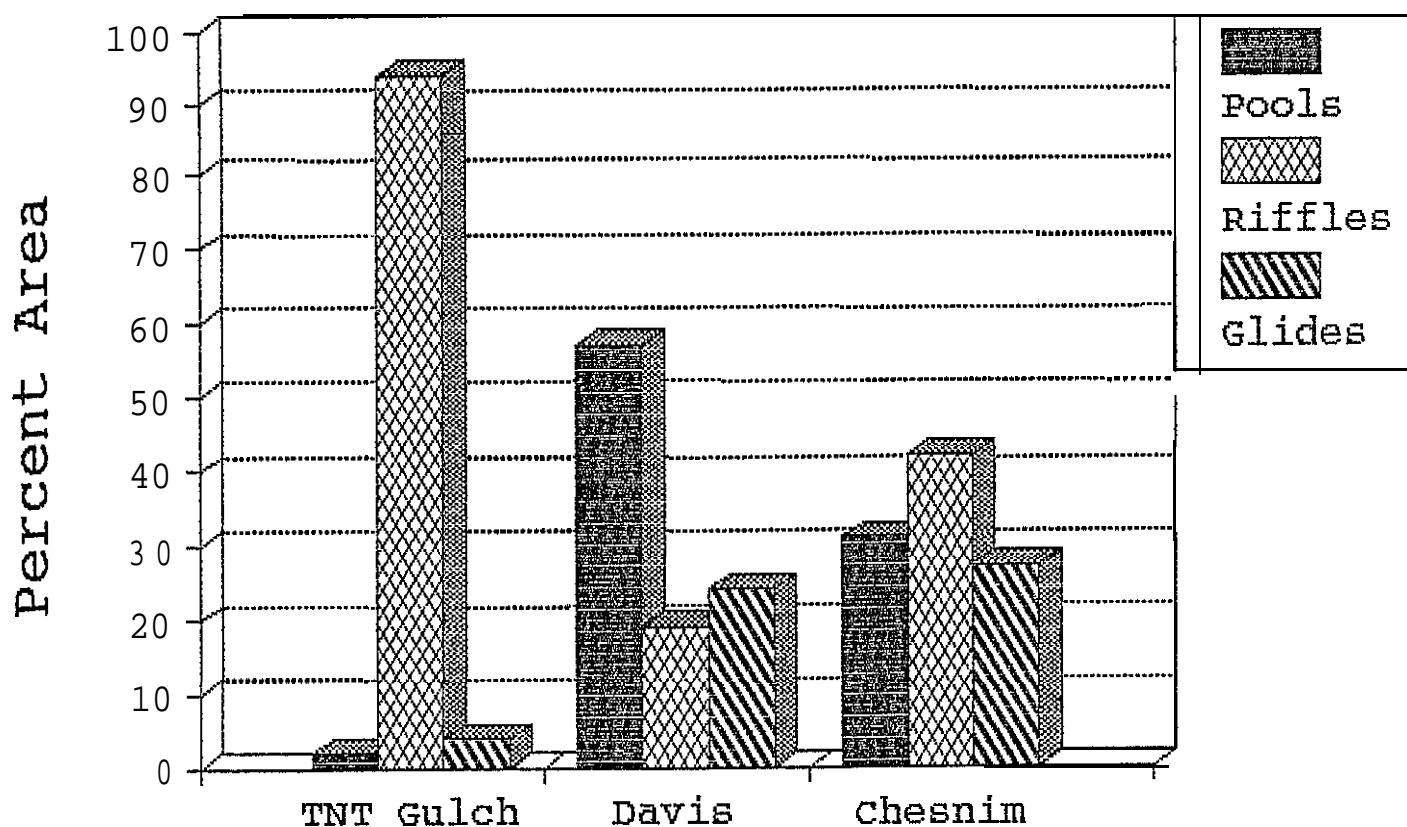
FIGURE 11. Stream morphology characteristics within BPA project areas for TNT Gulch, Davis Creek, and Chesnimnus Creek for 1991.

TNT Gulch had a high percentage of riffles (92%) and a low percentage of pools (3%). A survey conducted in 1966 by ODF&W showed 32% pools. Additionally, TNT Gulch is usually dry by August. The bankfull width/depth ratio is high (12) and indicates a wide and shallow channel. The amount of large woody debris was 12 pieces/mile.

Chesnimnus Creek had an even distribution of habitat types. There were 30% pools and 42% riffles in this section. ODF&W reported 75% pools in 1966. Average residual pool depth was 1.5 ft for this section. The bankfull width/depth ratio averaged 9. The amount of large woody debris was 18 pieces/mi.

Davis Creek was in the best condition of the streams surveyed this year. There were 55% pools with an average residual pool depth of 1.1 ft depth. ODF&W reported 70% pools in 1966. Average bankfull width/depth ratio was 7. The amount of large woody debris was 25 pieces/mile.

Based on ODF&W survey conducted 1966 the three streams surveyed this year have degraded since this time. Even though survey methods were different and an

exact change can not be determined it is nevertheless fair to say a change has taken place in the negative direction (e.g., TNT Gulch 32% pools to 3%). Other stream characteristics measured, for example woody debris, were lower than other streams in this region. Furthermore, this survey indicates salmonid habitat is in poor condition; some type of stream rehabilitation work is needed.
